No. 9746

Circuit Court of Appeals

J. LESLIE MORRIS COMPANY, INC., a corporation,

(Plaintiff's Exhibits 1 to 32)

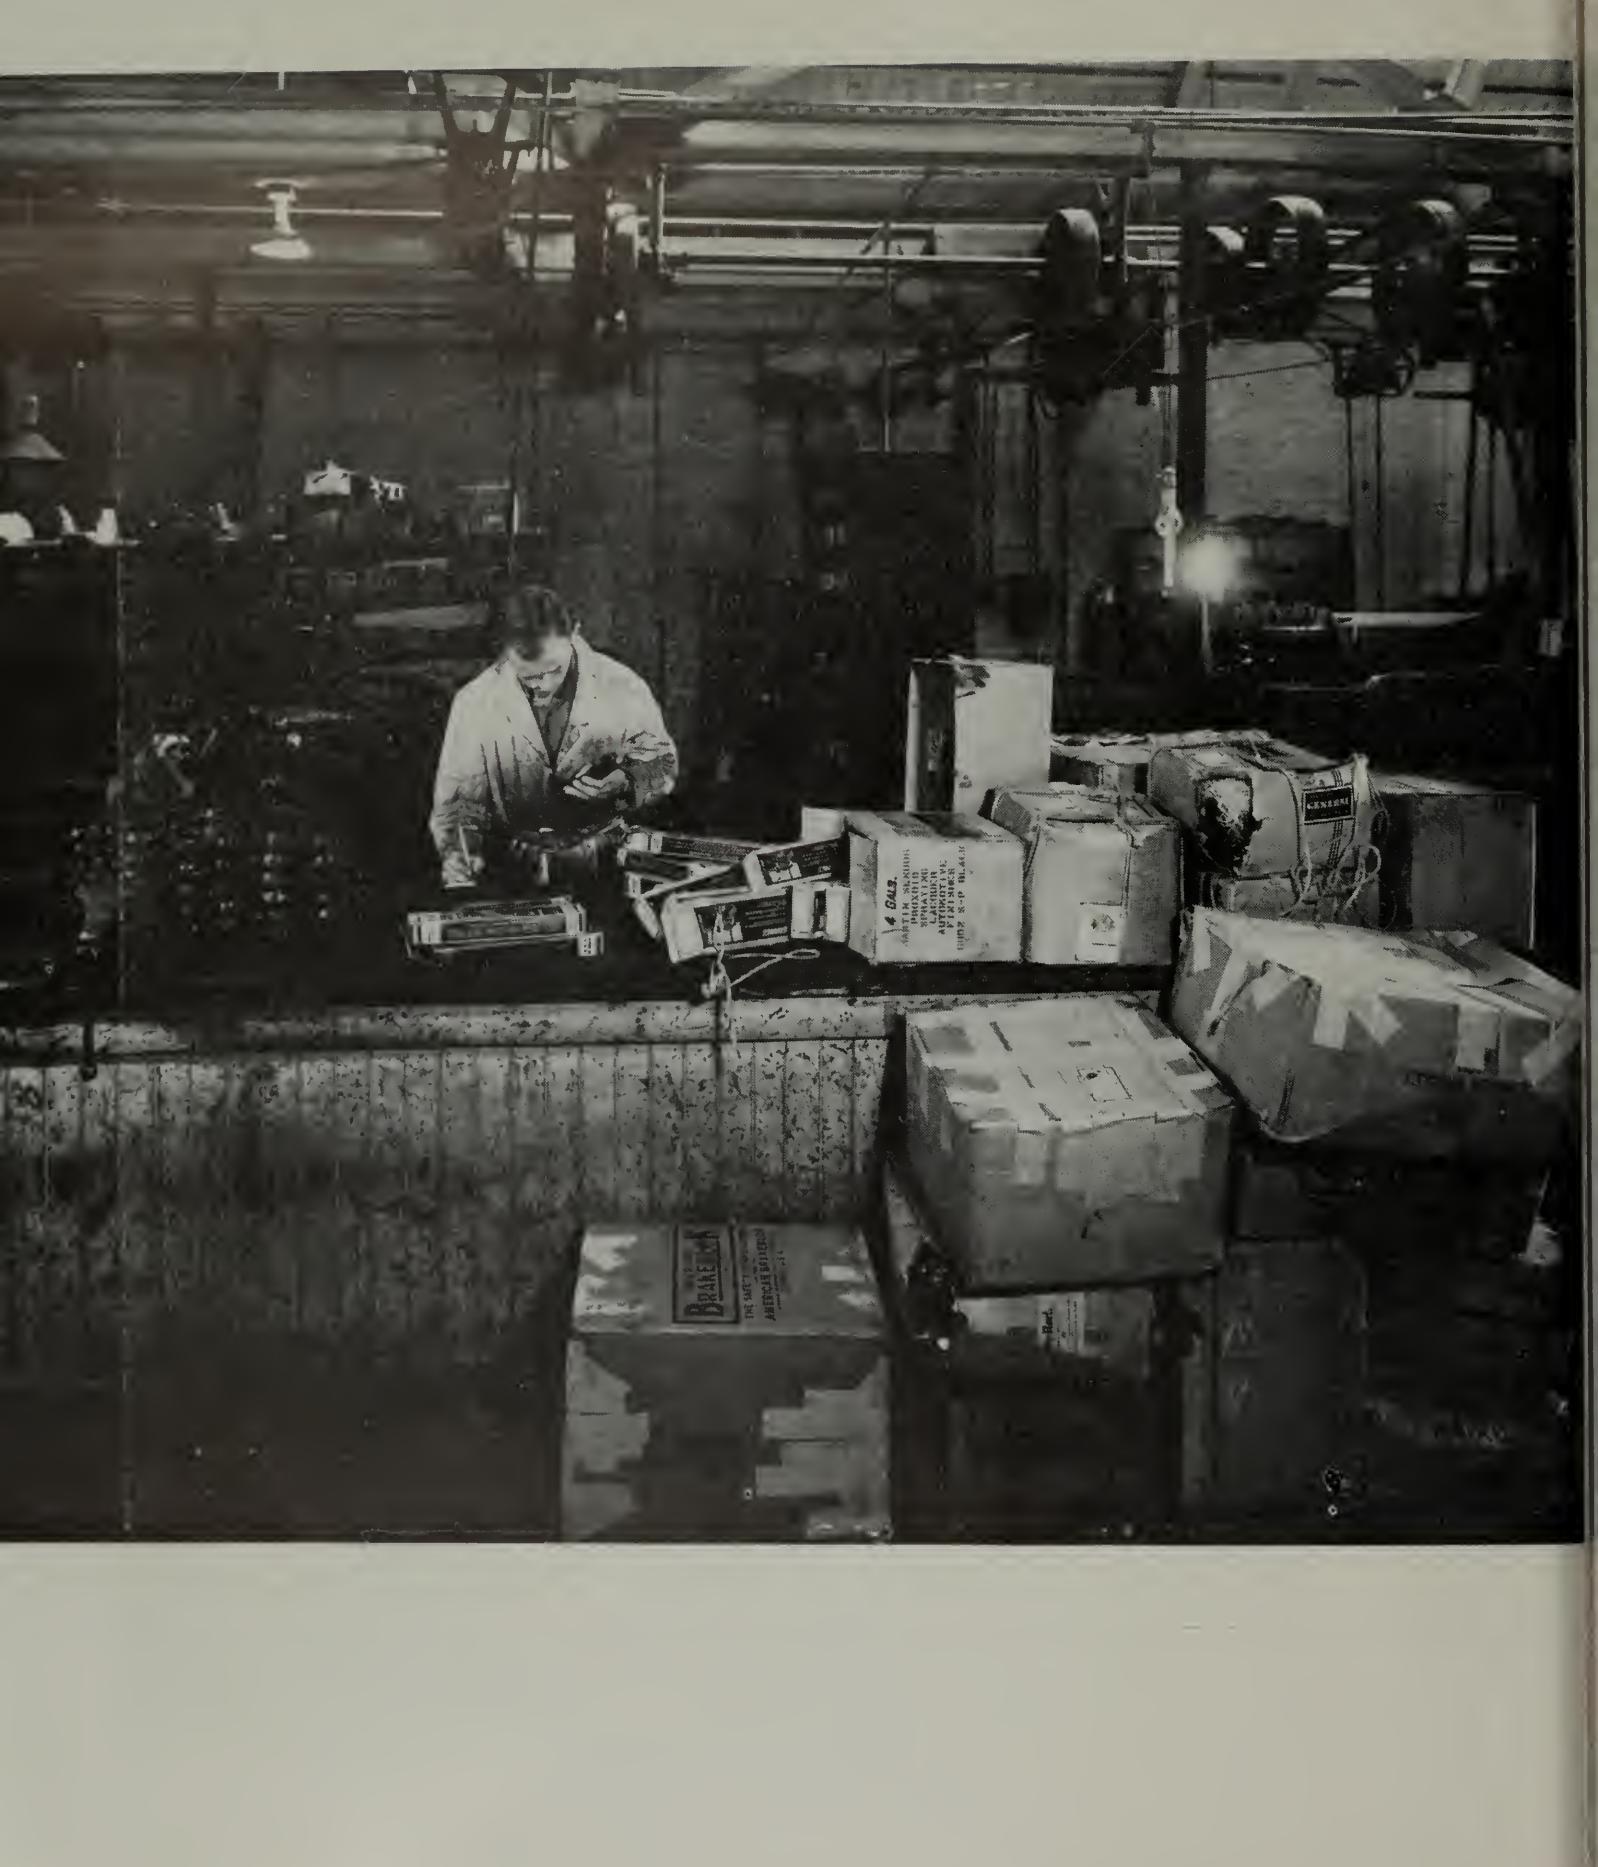
[Endorsed]: No. 433—M. Morris Co. v. U. S. A. Plt's Ex. No. 1. Filed 5/29/40. R. S. Zimmerman, Clerk. By B. B. Hansen, Deputy Clerk.

Packages containing the rods for rebabbitting are received each day. They are shipped to Plaintiff corporation from three principal sources: automotive supply merchants frequently called "jobbers" (for example, Western Auto Supply Company, Chanslor and Lyon Stores, Collvear Motor Sales Company, et cetera) representing about 85 per cent of the rods received by Plaintiff corporation; commercial accounts (for example, Barker Brothers, Greyhound Stages, Baker Ice Machine Company, et cetera) representing approximately 10 per cent of the rods received by Plaintiff corporation, and automobile dealers (for example, Paul G. Hoffman Company, Howard Auto Company, Greer Robbins Company, et cetera) representing about 5 per cent of the rods received by Plaintiff corporation. When the various packages of rods are received they are piled at or near the doorway of Plaintiff corporation as shown (above). Each shipper does not make his shipments daily but are only sent to Plaintiff corporation when sufficient accumulation warrants their shipment. They are received in packages varying from one to one hundred rods per package, however, averaging from twenty to sixty rods per package. They are brought in by either shippers own delivery service, by parcel post, or by various light trucking companies, or delivery services. About per cent of the rods sent in by automotive supply merchants i. e. "jobbers" are shipped to Plaintiff in Plaintiff corporation's boxes from which the rods rebabbited by plaintiff corporation have been sold. That is, the "jobber" in selling one of Plaintiff corporation's rods to a garage man or other purchaser removes from the box the rod delivered to him by Plaintiff corporation and takes the rod which the garage man has brought in for exchange and places it into the box from which Plaintiff corporation's rod was removed. This is only done for the purpose of enabling the "jobber" to keep the various sizes of rods segregated, otherwise in order to make up his invoice list for shipment to Plaintiff corporation it is usually necessary for the shipper to place an identification tag on the rod.

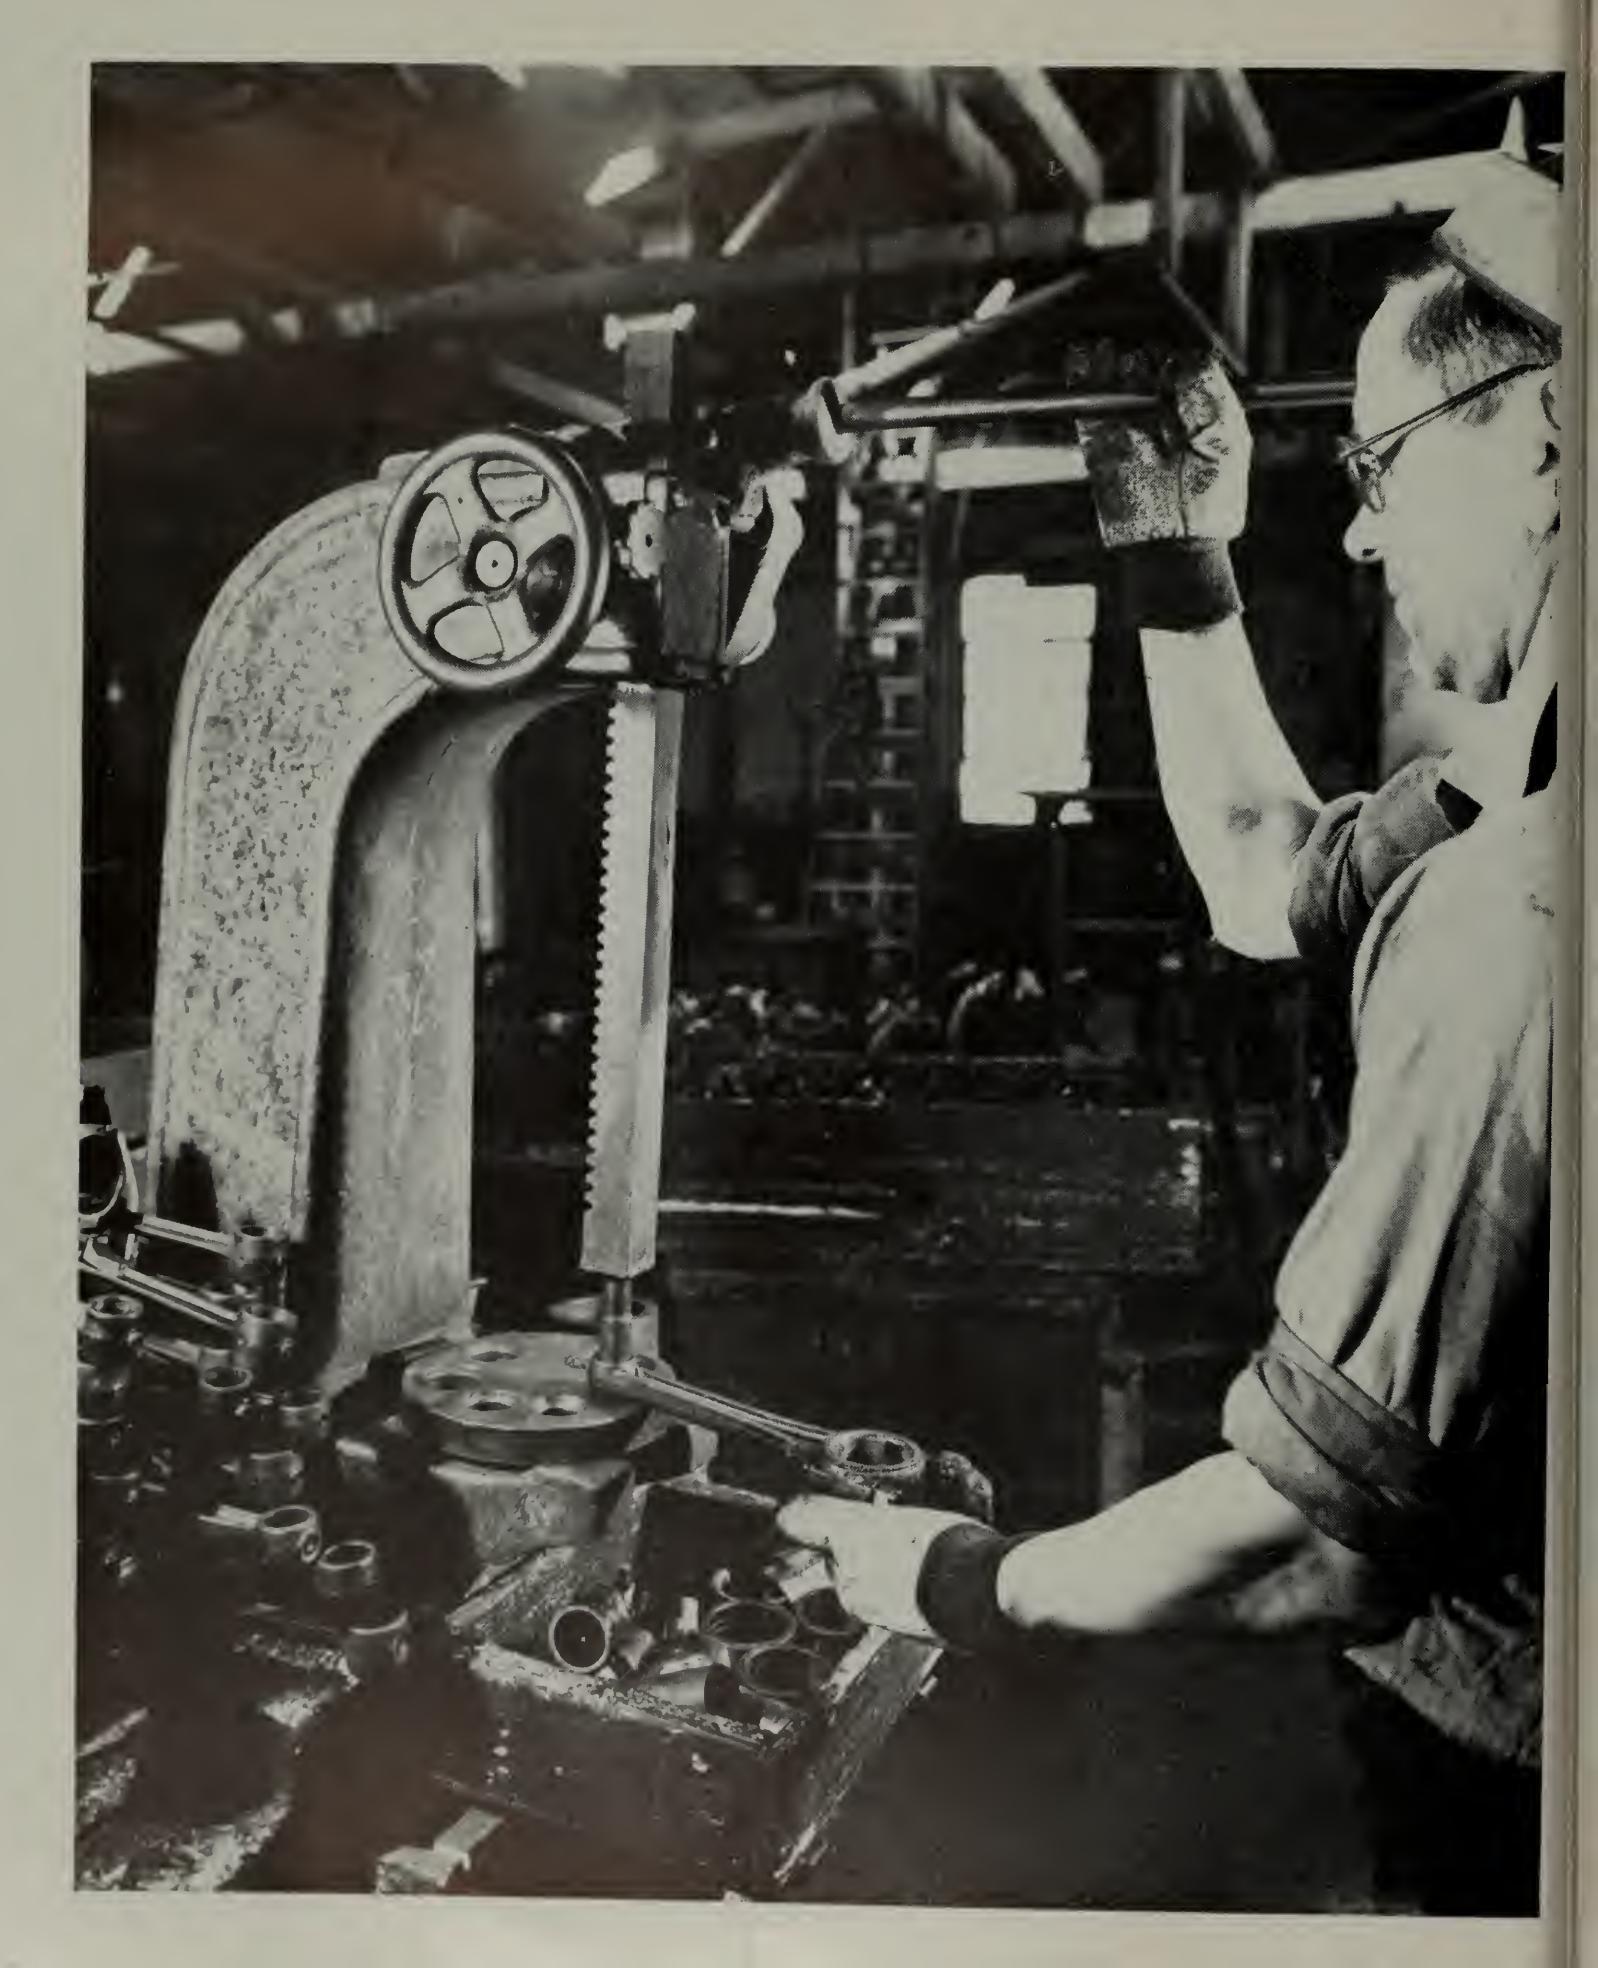
[Endorsed]: No. 433—M. Morris Co. v. U. S. A. Plf's Ex. No. 3. Filed 5/29/40. R. S. Zimmerman, Clerk. By B. B. Hansen, Deputy Clerk.

The rods are then piled on a table in groups according to their respective sizes and the pin bushings are removed. These pin bushings are the bushings at the shank end of the rod. About one half of the rods rebattitted by Plaintiff corporation use pin bushings. The other half are of a clamp type shank end and using no such pin bushings this operation of removal is not necessary. And sometimes the instructions received read "Do not change bushings." These pin bushings are of two types: Those with a thin wall which cannot be pressed out and which must be therefore pounded out by means of a cold chisel and hammer as shown above while

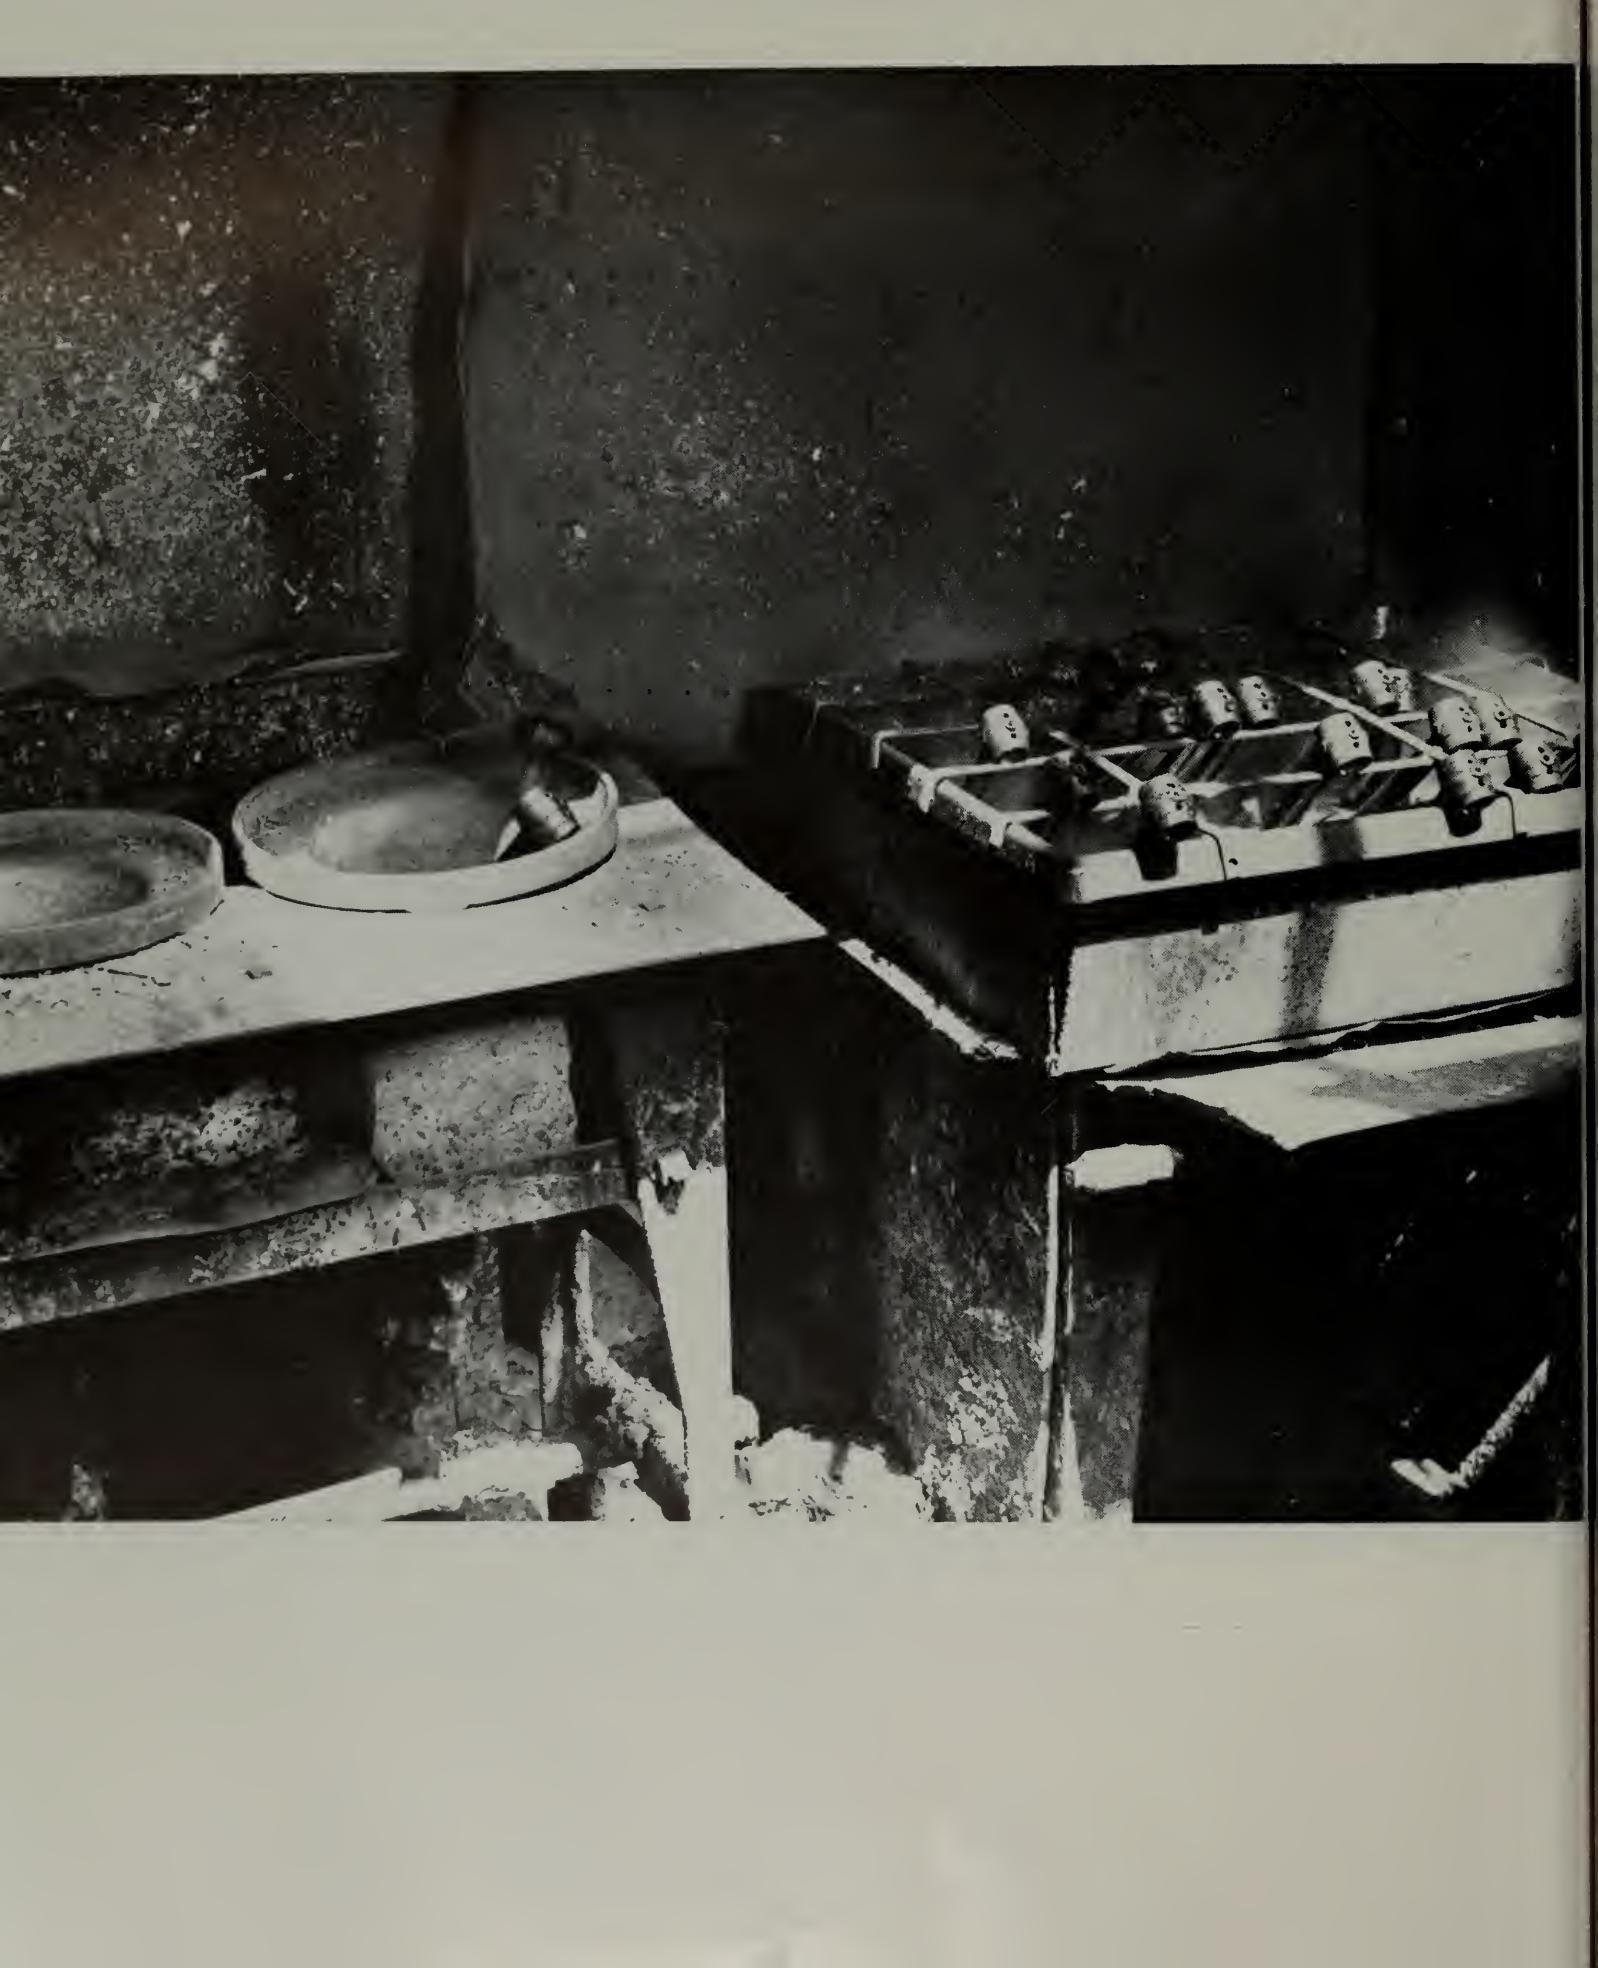
[Endorsed]: No. 433—M. Morris Co. v. U. S. A. Plf's Ex. No. 6. Filed 5/29/40. R. S. Zimmerman, Clerk. By B. B. Hansen, Deputy Clerk.

Then the babbitt is melted from the bearing end of the rod by placing that end into a low temperature pot of molten babbitt which the night man prepares by lighting the oven at approximately five o'clock in the morning in preparation for the days run. It is heated with an ordinary gas stove burner. This operation is illustrated in the right half of the above picture. After most of the babbitt is removed by this method, the remainder of the adhering babbitt or dross which sometimes clings to the rods is removed by dipping them into the dross pots shown to the left in the above picture. The dross pots keep a solution of molten babbitt at a higher temperature. In order to keep the babbitt at a sufficiently high temperature three approximately one half gallon pots are used. The reason for the babbitt being removed by two operations is that the babbitt in the low temperature receptacle may be used by Plaintiff corporation for rebabbitting, while the higher temperatures in the dross pots spoil the babbitt for such use.

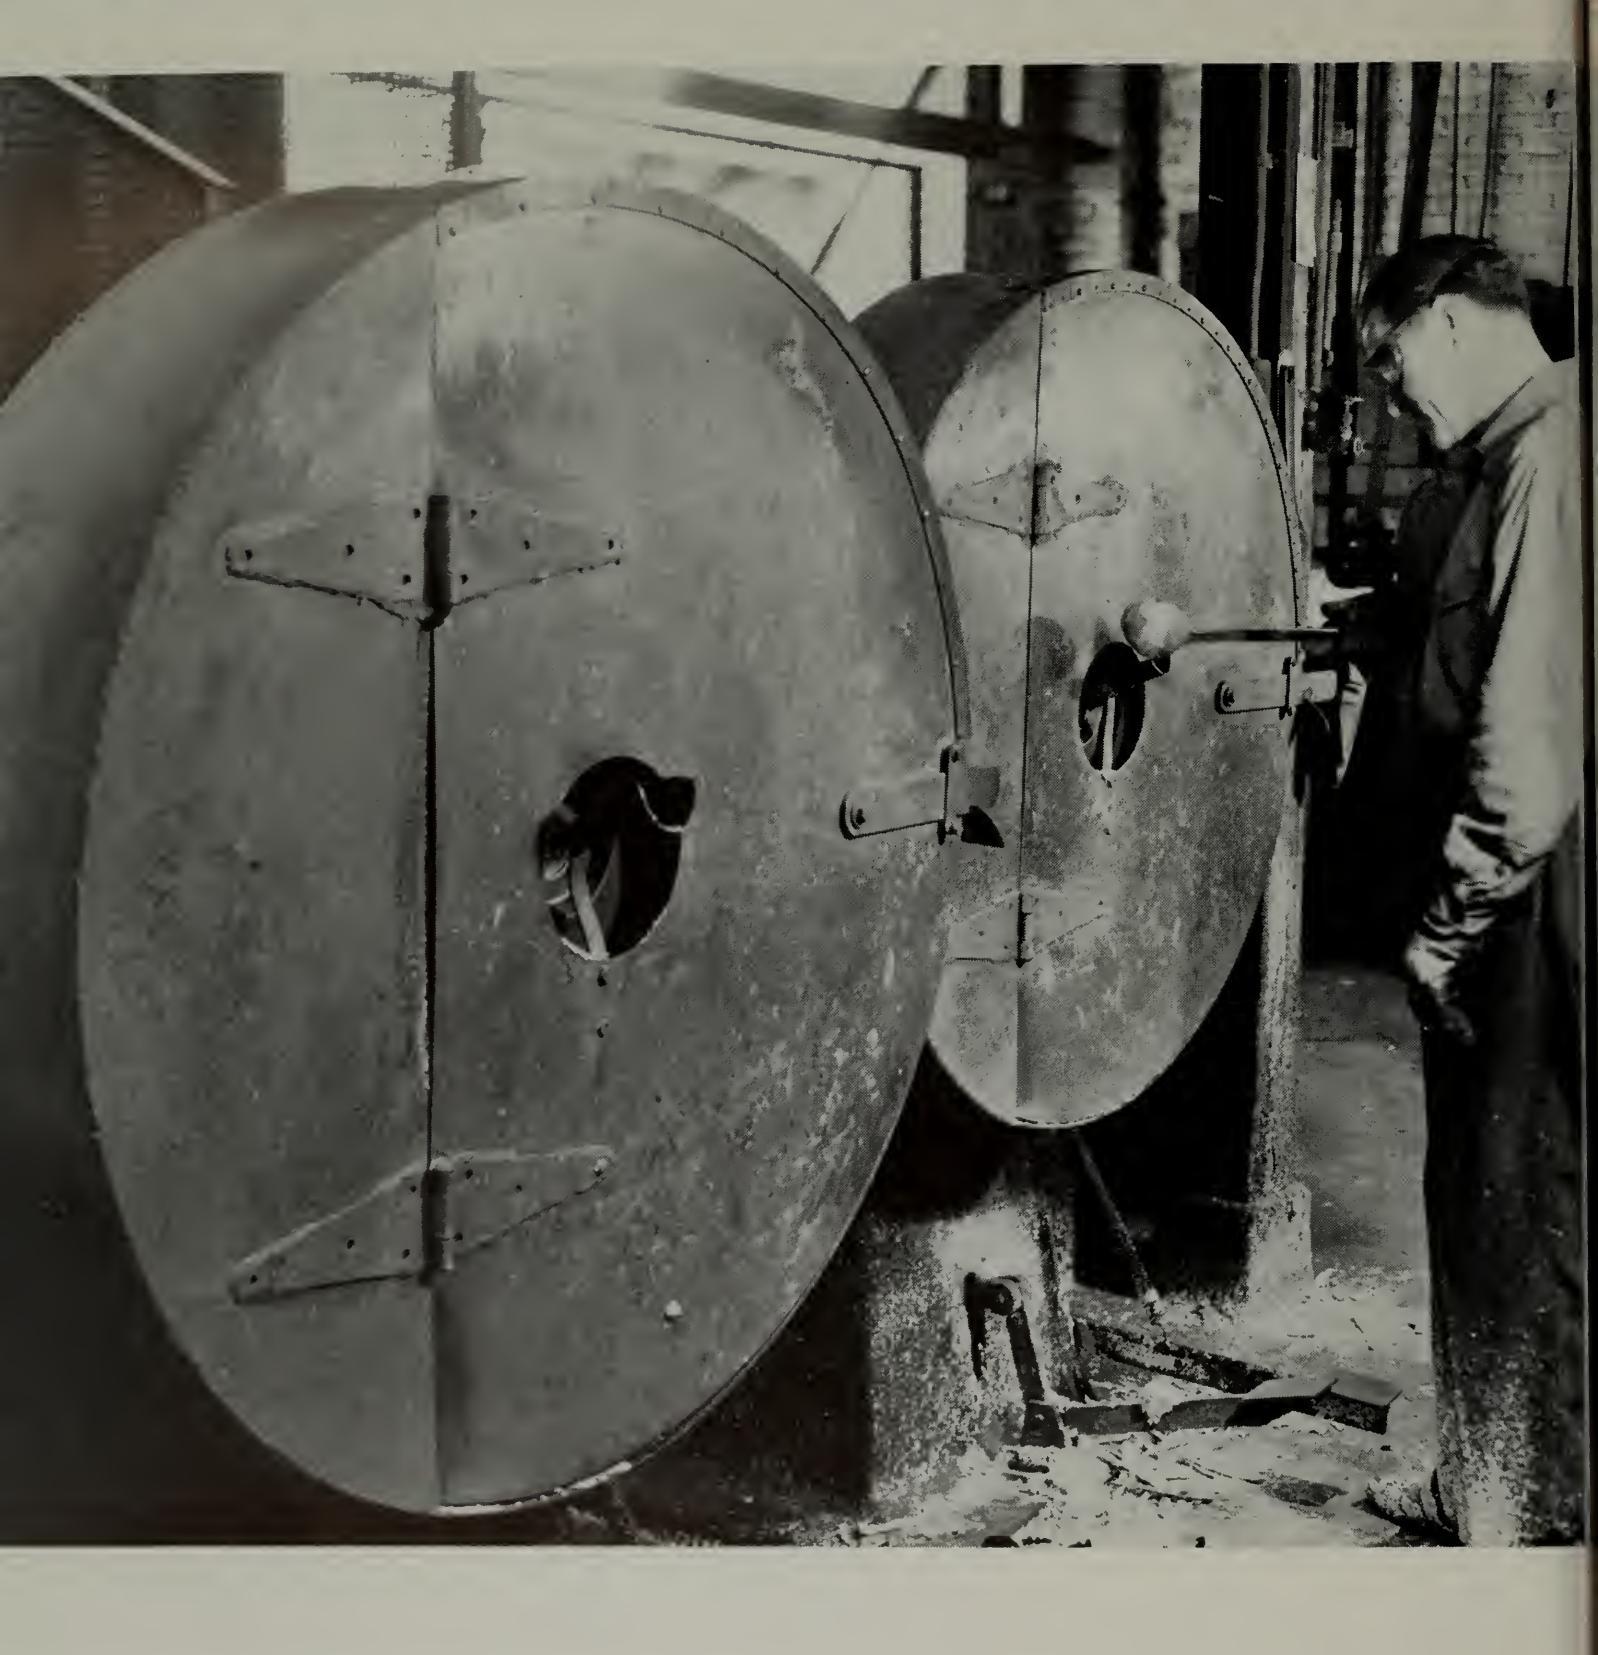
[Endorsed]: No. 433—M. Morris Co. v. U. S. A. Plf's Ex. No. 11. Filed 5/29/40. R. S. Zimmerman, Clerk. By B. B. Hansen, Deputy Clerk.

The rods are then taken to the centrifugal casting machines which were built by Plaintiff corporation for its own use. There are two of these machines because it takes the babbitt about fifteen seconds to cast and thus one operator can run the two machines. Each of these centrifugal casting machines consists of a revolving shaft on which is mounted a mold holder shown above. This mold holder is opened by means of a foot lever and the bearing end of the rod is placed between the molds which cup over each side of the bearing end. The illustration above shows the operator with his right hand covering the shank end of the rod with the bearing end in between the mold seen in the picture snaps back against the bearing end of the rod holding the rod securely so that it makes a perpendicular axis to the shaft on which the mold holder is mounted.

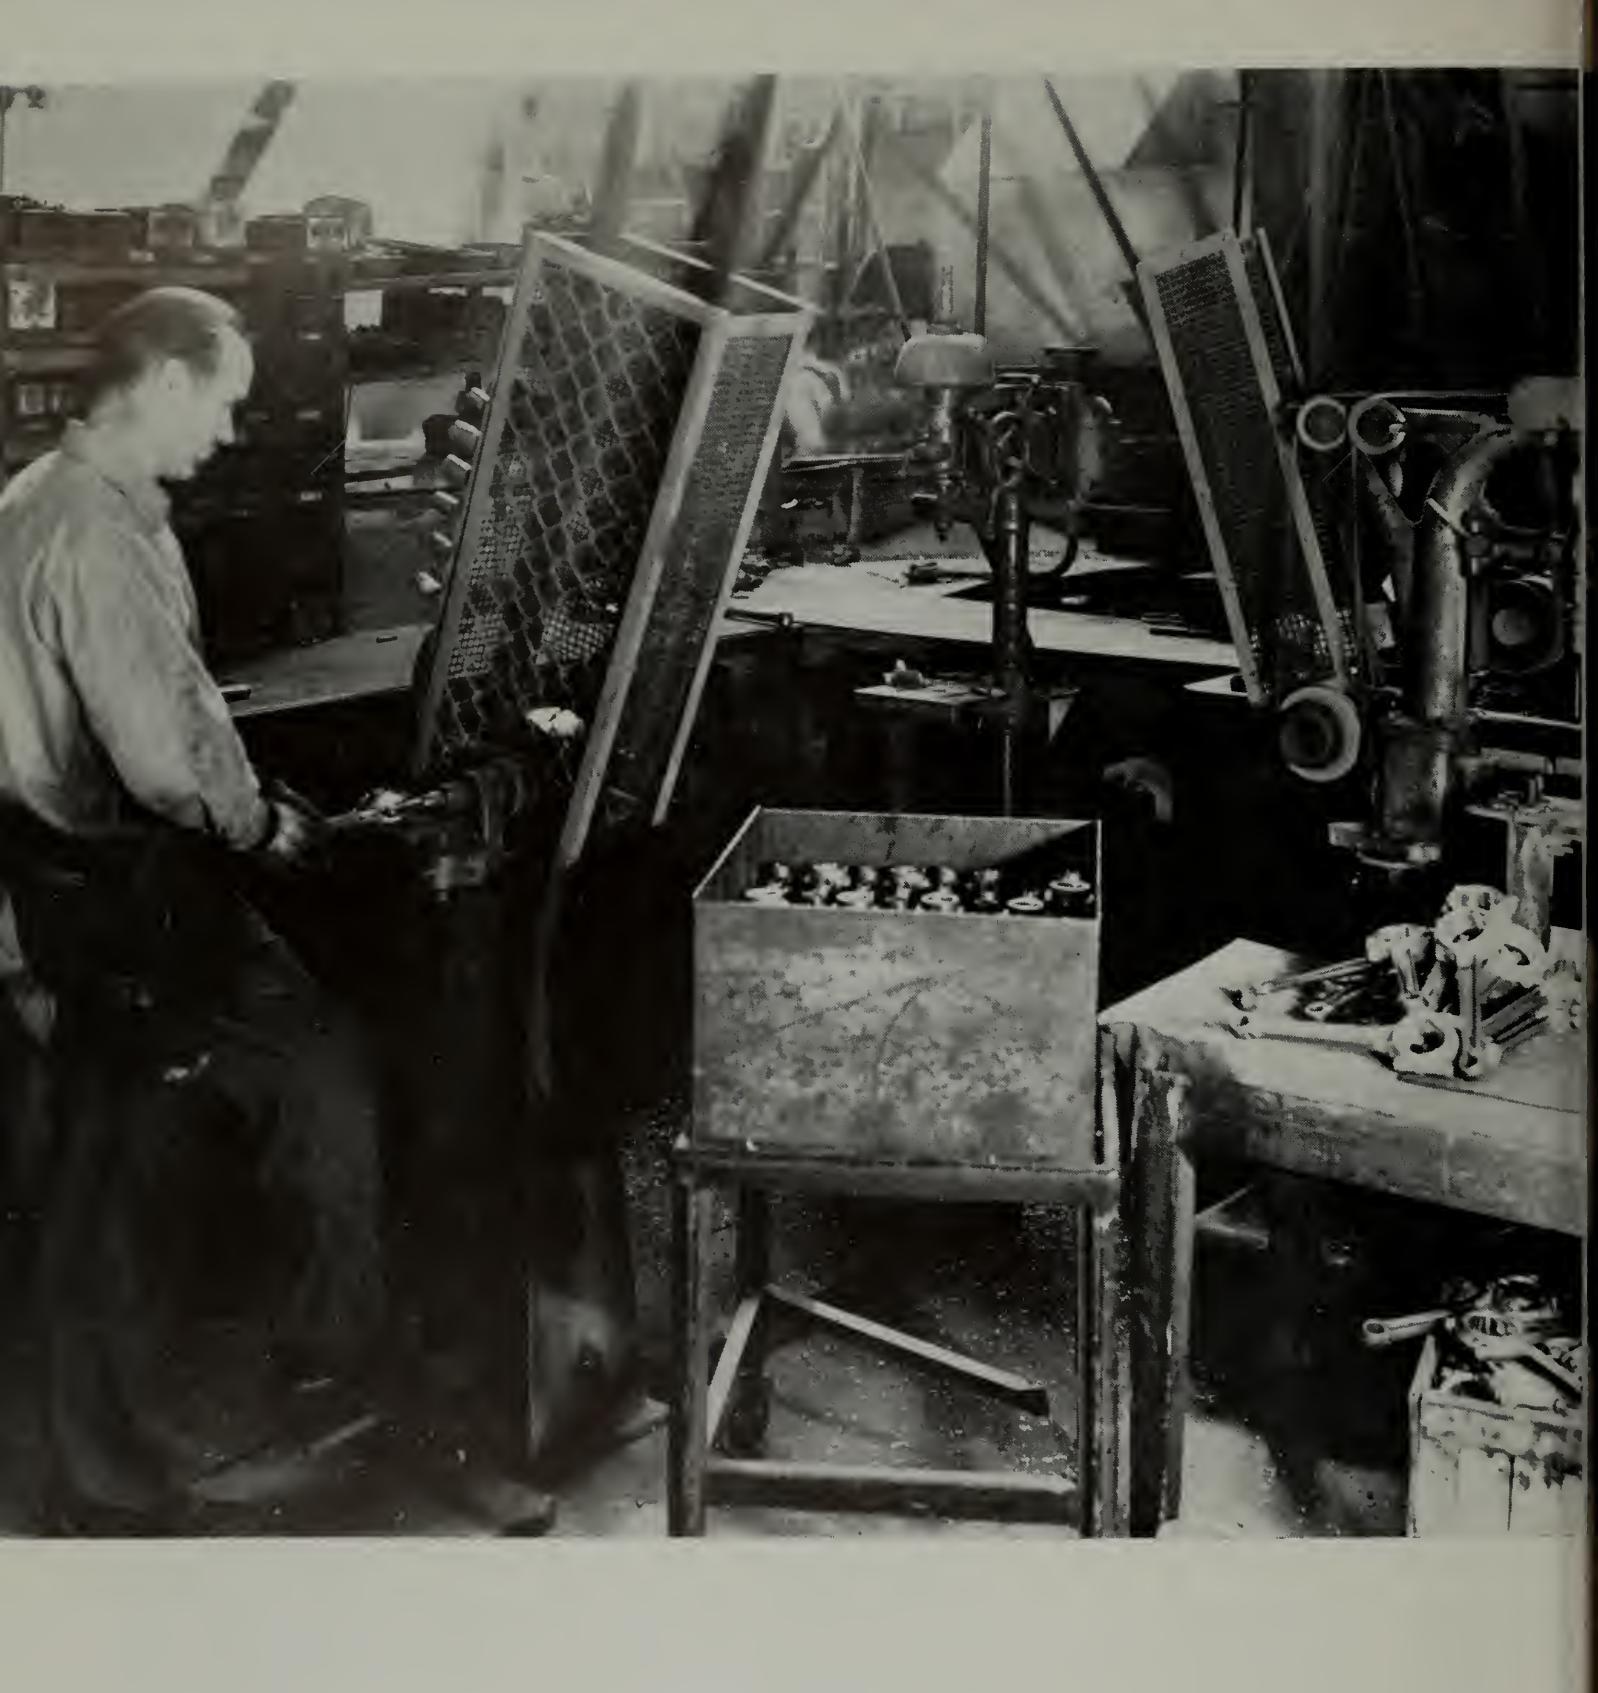
[Endorsed]: No. 433—M. Morris Co. v. U. S. A. Plf's Ex. No. 16. Filed 5/29/40. R. S. Zimmerman, Clerk. By B. B. Hansen, Deputy Clerk.

However, before the cap is fastened to the bearing end of the rod any ragged edges of babbitt which may have adhered where the shims separated the cap from the bearing end of the rod are removed by holding the open face of the cap or the open face of the bearing end of the rod against the revolving sandpaper disc as shown above.

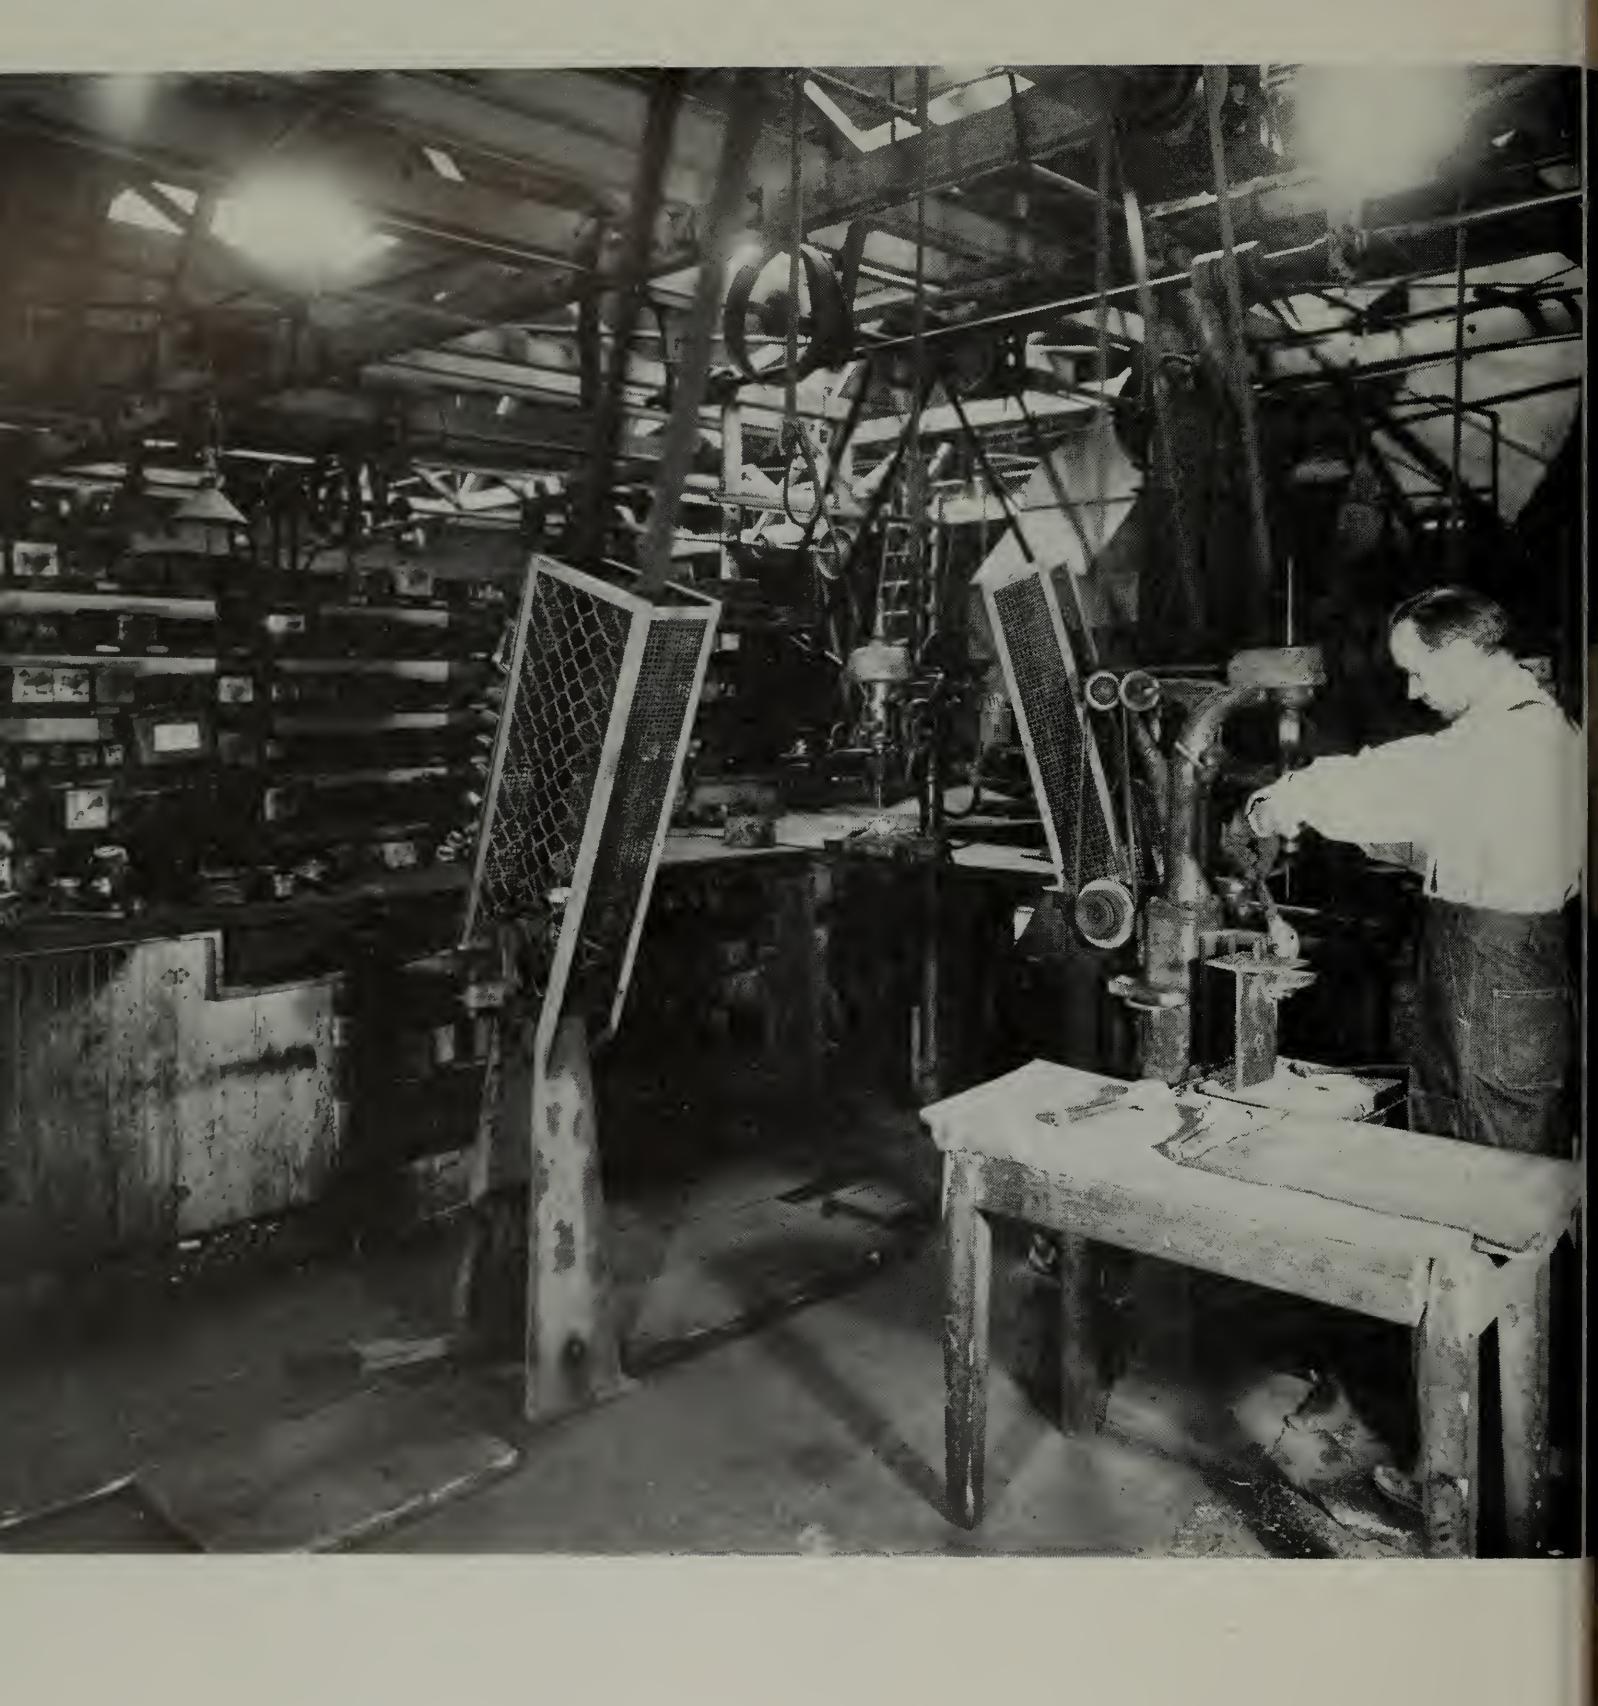
[Endorsed]: No. 433—M. Morris Co. v. U. S. A. Plf's Ex. No. 18. Filed 5/29/40. R. S. Zimmerman, Clerk. By B. B. Hansen, Deputy Clerk.

The operator cleans out the oil holes by use of a drill press as shown in this picture.

The oil holes are not always the same size. Accordingly, the operator uses a second drill press with a larger drill to perform the same operation shown in Picture 18. This removes the necessity for frequently changing drills.

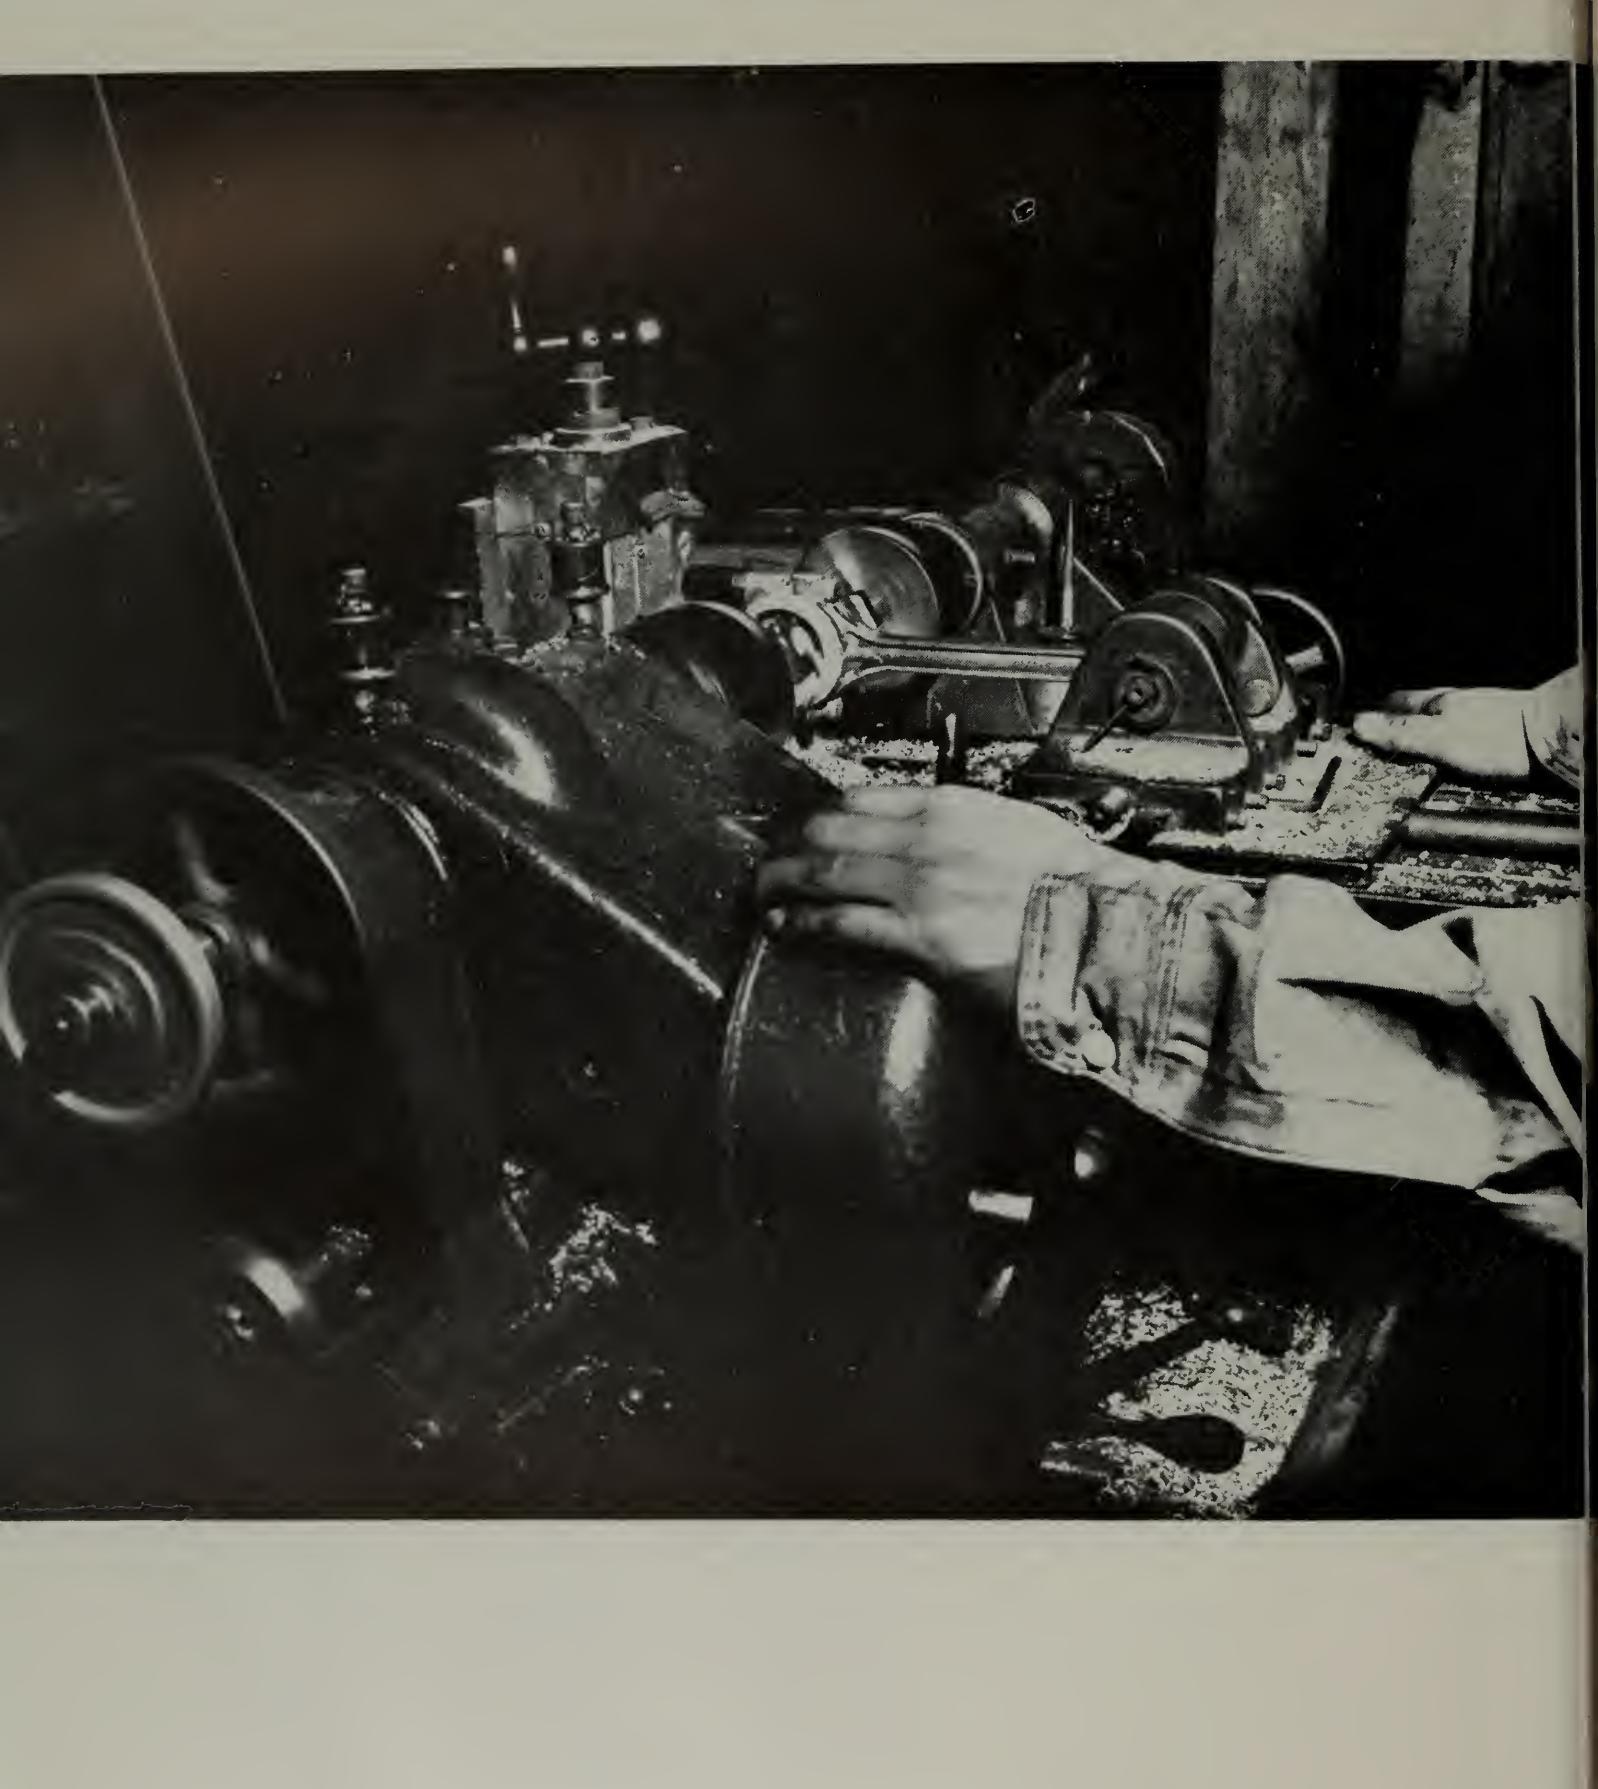
[Endorsed]: No. 433—M. Morris Co. v. U. S. A. Plf's Ex. No. 21. Filed 5/29/40. R. S. Zimmerman, Clerk. By B. B. Hansen, Deputy Clerk.

The rod is now placed in a lathe and the babbitt is bored, faced and chamfered. The latter two operations finishes the bearing to standard width.

The lathe used in the above picture is identical with the one shown in Picture 21, however it is used for finishing babbitt bearings to special undersizes as ordered by the customer. About 20% of the connecting rods rebabbitted by the plaintiff are bored to special undersizes for the reason that the crankshafts of the automobiles in which they are to be placed have been reground in order to correct for the wear which has resulted from long operation.
